# Mineral Fibre Loft Insulation, Workmanship, Ventilation & Condensation

A WHITE PAPER

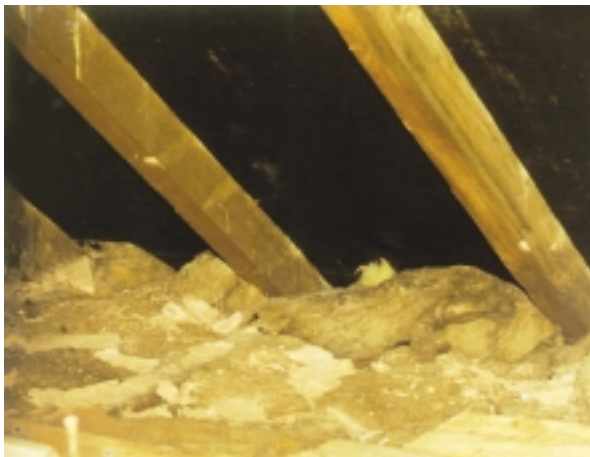
4.1 All properties had some degree of blocked ventilation paths due to overfilling of the eaves and typically the majority of the spaces between rafters at the eaves were completely blocked by the mineral fibre quilt. In many cases the mineral fibre had been laid in such a manner that it contacted the underside of the sarking felt across the entire space between rafters. The majority of units were found to have 80% or more of the ventilation spaces filled with mineral fibre quilt.

**Image 1**  
This image is of property #37 Street A. It shows mineral fibre blocking eaves ventilation.

- 6.7 A more improved method would be the installation of proprietary eaves vent trays under which the mineral fibre quilt could be tucked, thereby maintaining the continuity of insulation whilst not impeding ventilation.

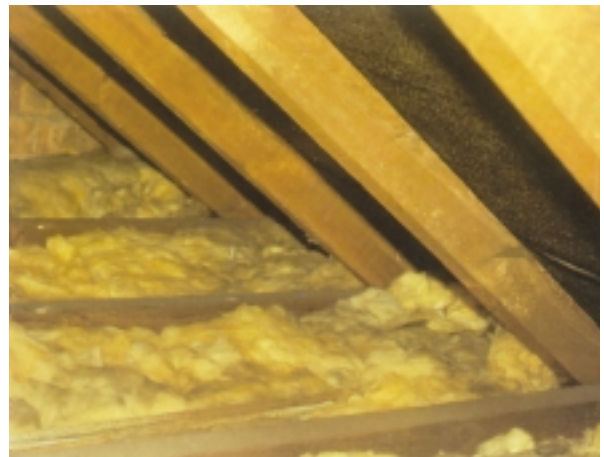
**Image 3**  
This image is of property #4 Street B. It shows mineral fibre blocking eaves ventilation.

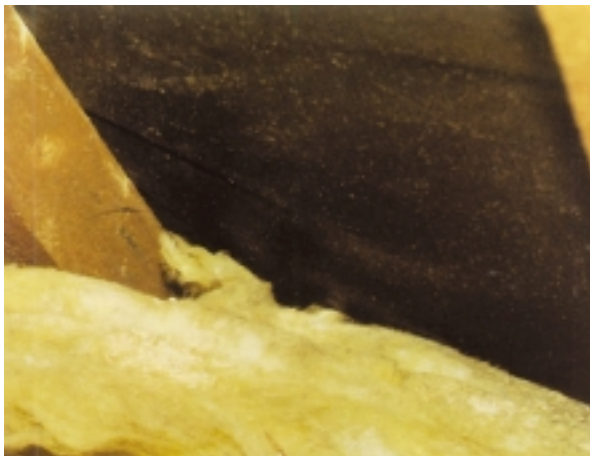
**Image 2**  
This image is of property #57 Street A. It shows mineral fibre blocking eaves ventilation.

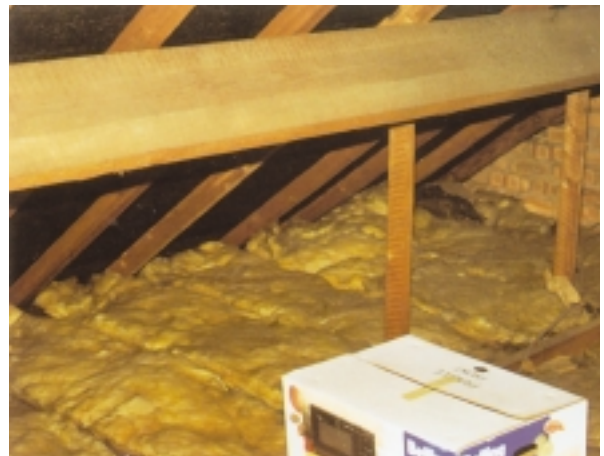
**Image 4**  
This image is of property #36 Street B. It shows mineral fibre blocking eaves ventilation.

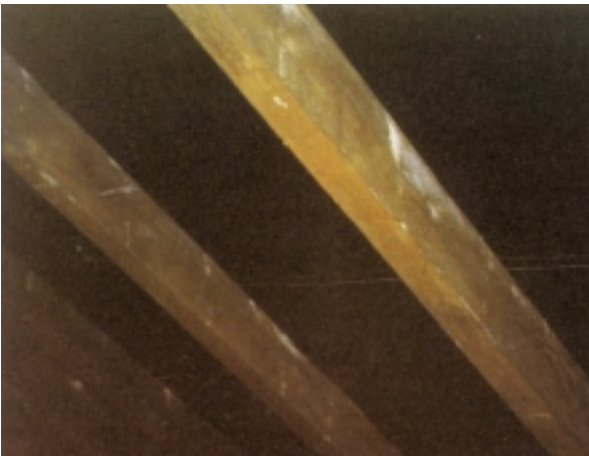
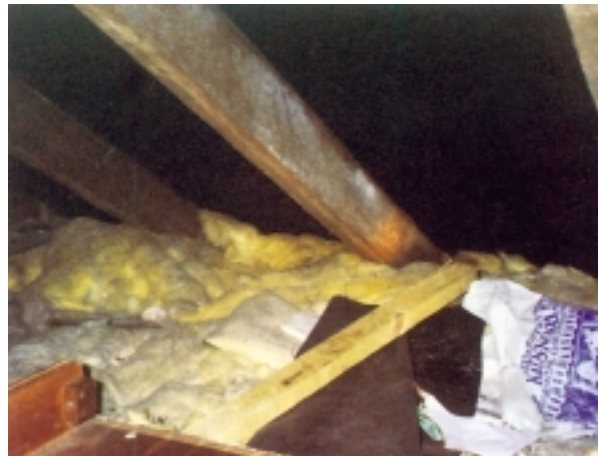
- 4.4 Ten of the thirty five properties were found to have some signs of moisture staining or mould growth on the roof timbers. This mould growth is likely to be directly related to the lack of effective ventilation. While the majority of affected areas were relatively small and sporadically located, one loft (#65 Street A) in particular showed more advanced levels of mould growth and recorded an average timber moisture content of 18% by weight (normal acceptable range is 5-20% by weight). Another property (#29 Street A) showed larger patches of staining on one rafter in particular, however, the timber moisture content at the time of inspection was low (10% by weight). Areas of such moisture staining can be seen in images 5 & 6 below. In general the moisture content of the roof timbers ranged between 10-13% by weight.

**Images 5 & 6**  
These images are of property #65 Street A. They show moisture staining of timber rafters.

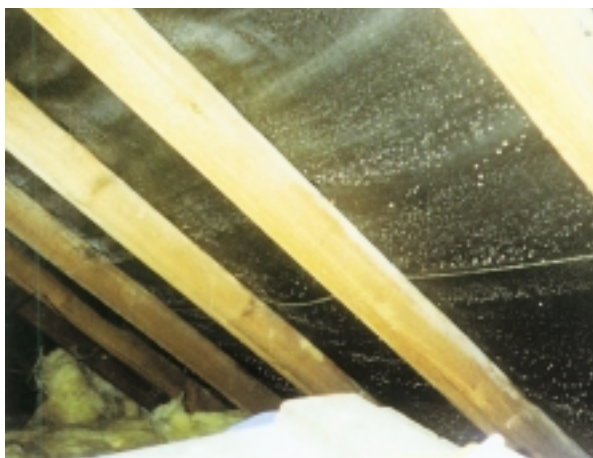
- 5.5 Where condensation formed it typically covered the entire space between rafters and the size of the droplets ranged between 5-15 mm.

**Image 7**  
This image is of property #47 Street A. This image shows condensation occurring on the underside of the sarking felt covering the entire space between rafters. The droplets ranged between 5-10 mm.

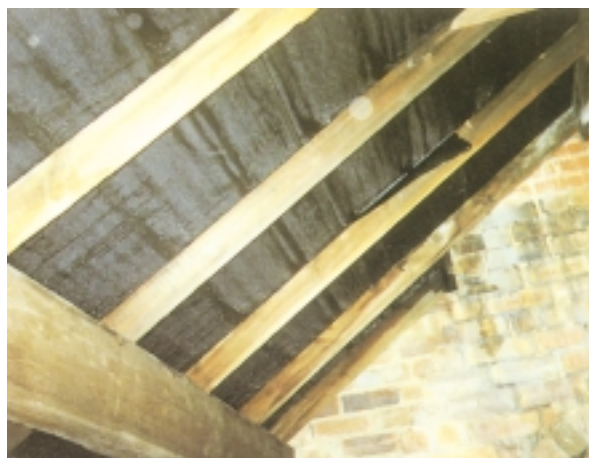
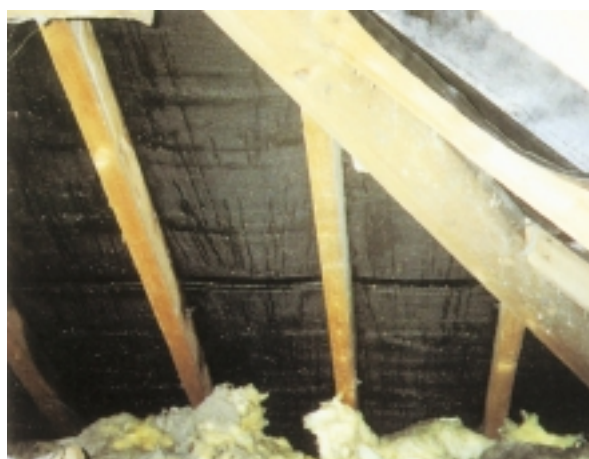
- 5.4 In general, the condensation was concentrated on the sarking material around the lower levels of the roof spaces adjacent to the eaves. In most properties it appeared that the higher surfaces, being slightly warmer due to the stack effect, had little or no formation of condensation, although condensation up the entire roof pitch from eaves to ridge could be seen in #37, 51, 57 and 76 Street A.

**Images 8 & 9**  
These images are of properties #51 & 57 Street A. They show condensation occurring on the underside of the sarking felt with a greater concentration of droplets around the lower levels of the roof space.

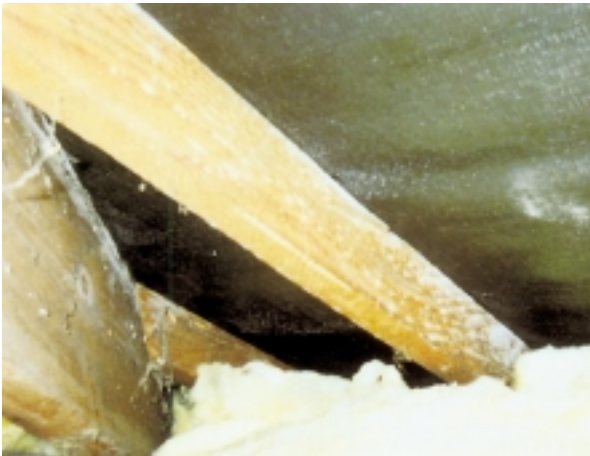
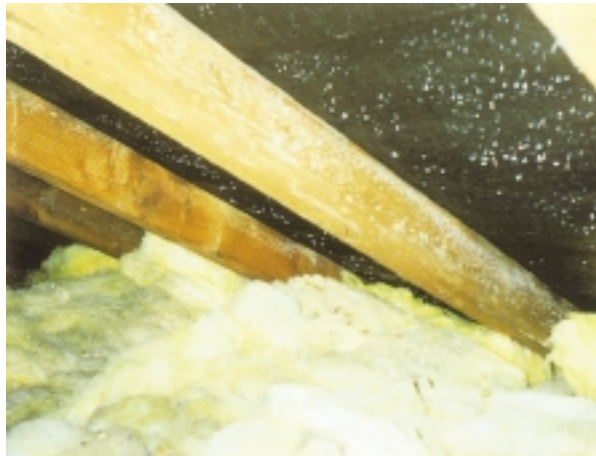
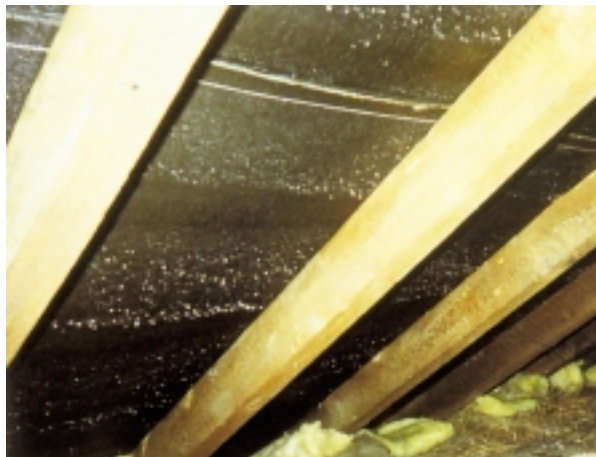
Images 10, 11 & 12  
These images are of properties #81 & 83 Street A. They show signs of mould growth on rafter sides.

5.7 Signs of mould were identified on the rafters in four of the seventeen properties surveyed. (#47, 81, 83 and 90 Street A.) In each loft affected, the mould was forming on the side of the rafters adjacent to those areas with the most severe condensation.
