# Mineral Fibre Loft Insulation, Cold Bridging, Ventilation & Heat Loss at the Eaves

A WHITE PAPER

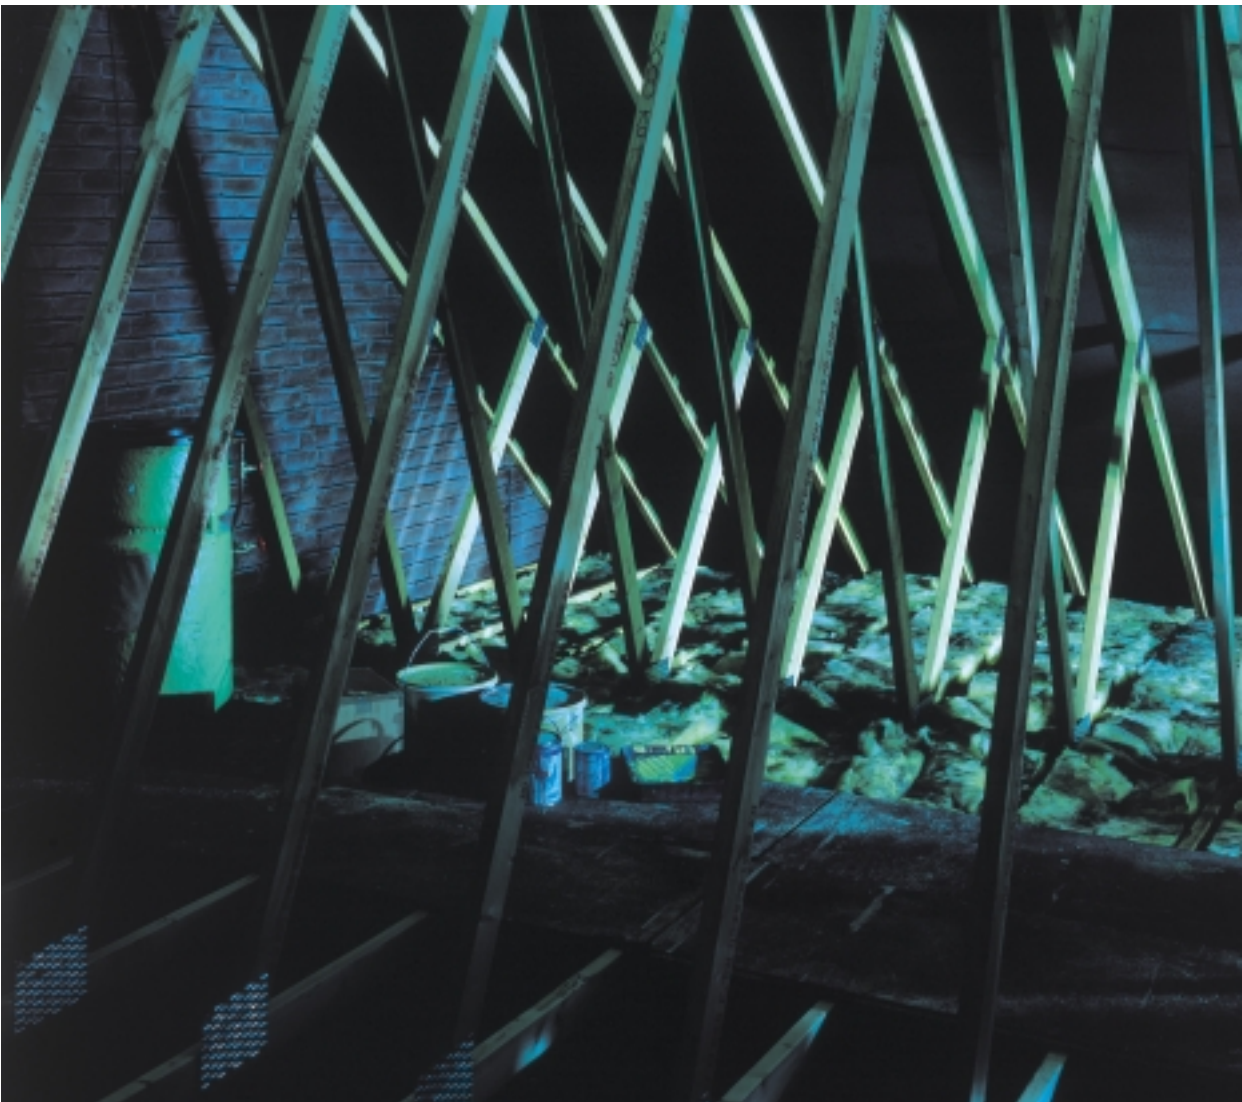
## 2 Ventilated Lofts – Traditional Construction

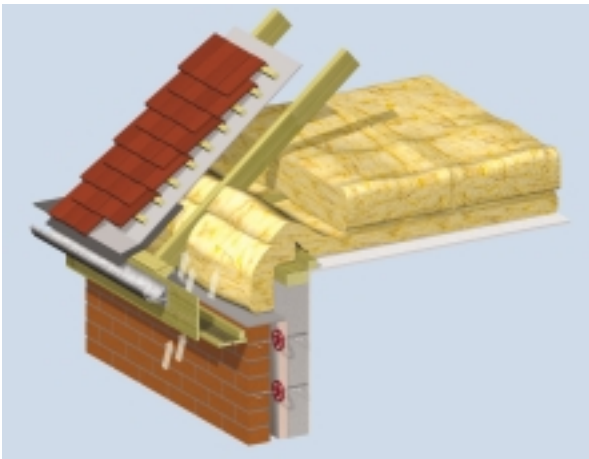
Figure 1 If eaves ventilation becomes blocked because of insulation pushed into the eaves, free movement of air may be restricted, and this could result in condensation.

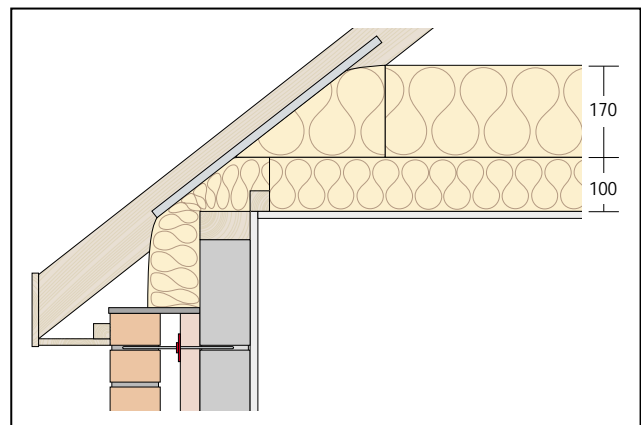
1. Manual of Medical Mycology by John Thorne Crissy, Heidi Lang, Lawrence Charles Parish, Blackwell Sciences, Cambridge, Massachusetts, 1995. 263p.  
2. Mould Allergy, Yousef Al-Doory and Joanne F. Domson, Lea and Febiger, Philadelphia, 1984, 287p.

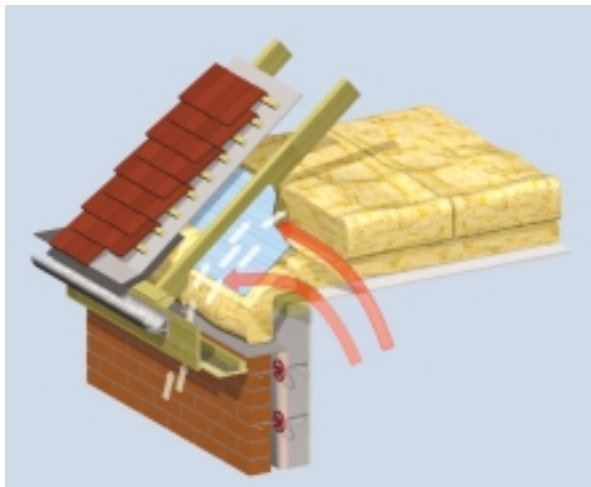
Figure 3 If the loft is insulated without compressing the over-joint layer of insulation into the void below the eaves ventilation tray, an even more significant cold bridge can be created.

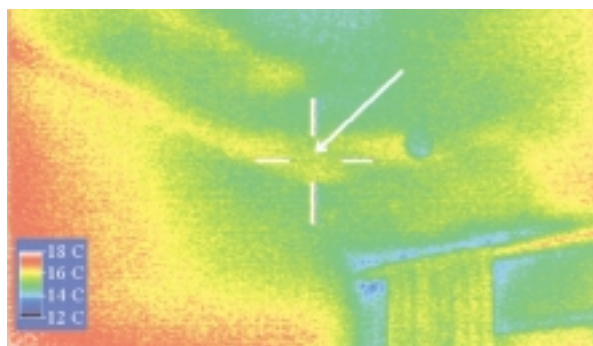
Figure 4 This thermographic image shows the rear bedroom ceiling from one of the properties. There is a small area 1 metre long (arrowed) where the mineral fibre stops short of the eaves. This is seen as the yellow rectangular pattern. The narrow yellow band above the pattern is also noted and indicates that a gap in the mineral fibre above the ceiling joist exists at this location.

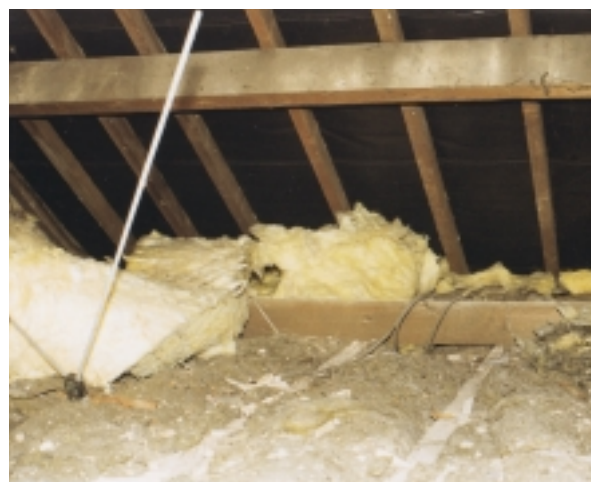
Figure 5 This photograph from the local authority study shows the additional layer of mineral fibre insulation missing from a substantial portion of the loft.

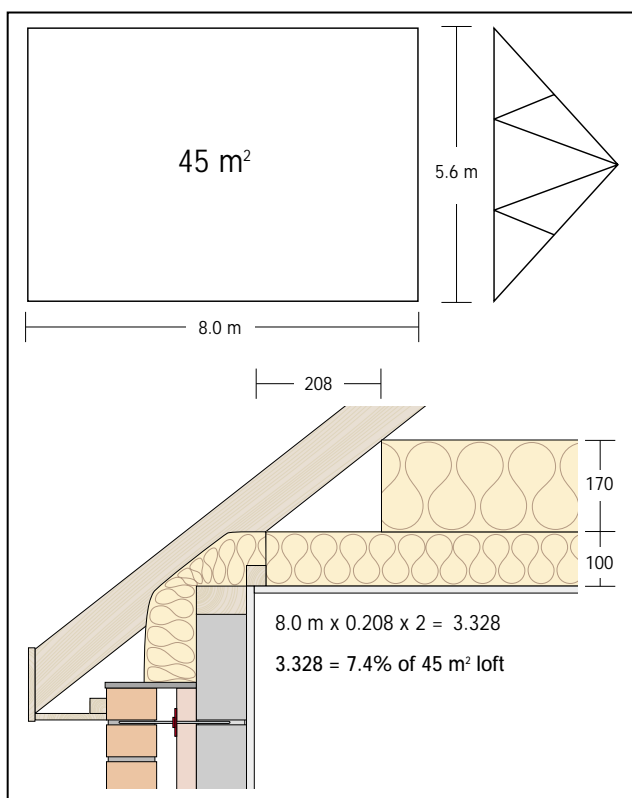
## 5.3 Missing Insulation in General

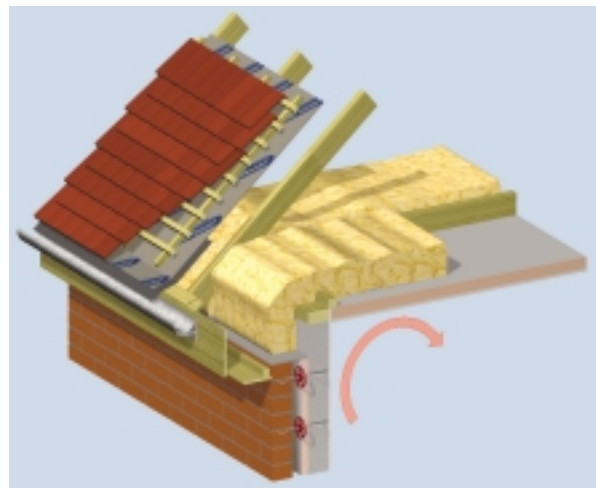
Figure 7 *Kingspan nilvent*<sup>®</sup> breathable membrane installed over rafters to create a sealed unventilated loft space. The use of *Kingspan Kooltherm K18 Insulated Dry-lining Board* below the ceiling floor joists results in the depth of loft insulation being reduced to more manageable levels.

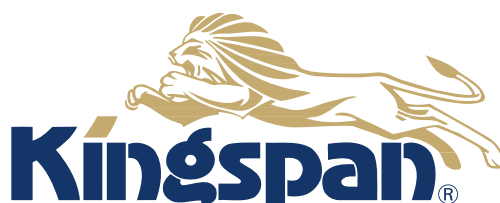
**Kingspan Insulation Ltd**
