# Mineral Fibre Loft Insulation, Workmanship, Ventilation & Condensation

A WHITE PAPER

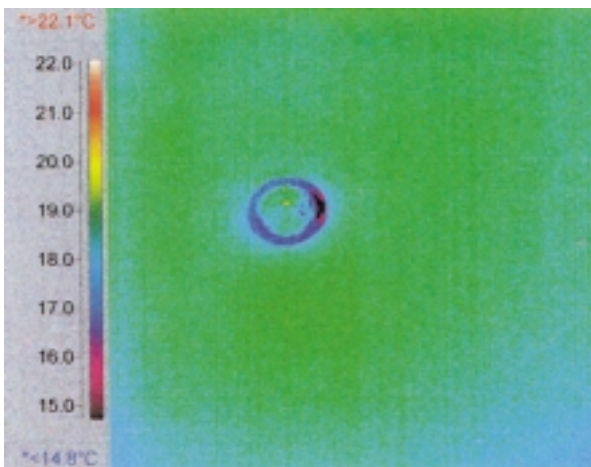
**Image 13**  
The even surface temperature indicates a well performing Kingspan Insulation warm pitched roof system. The small circular shape in the centre of the image is a spot light fitting which is switched off.
